St Martin's Cathedral Leicester

Application to FAC to discharge CFCE consent condition

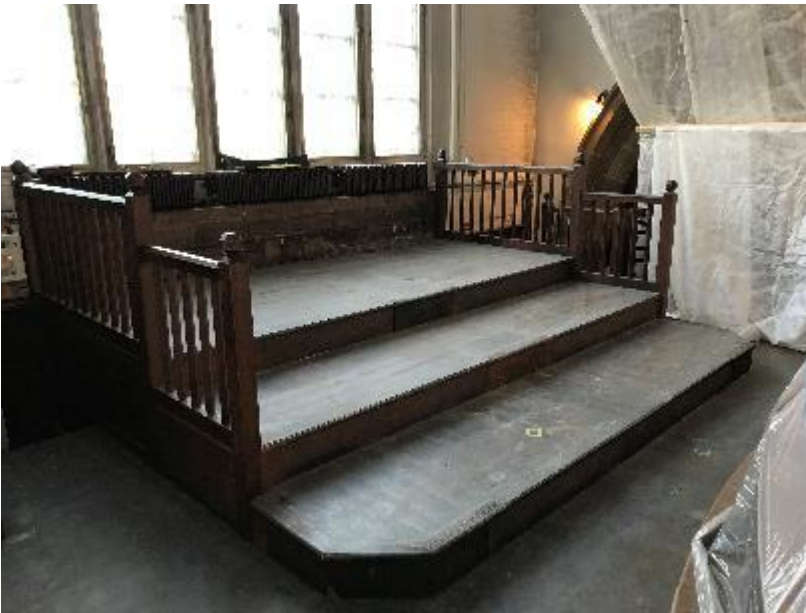
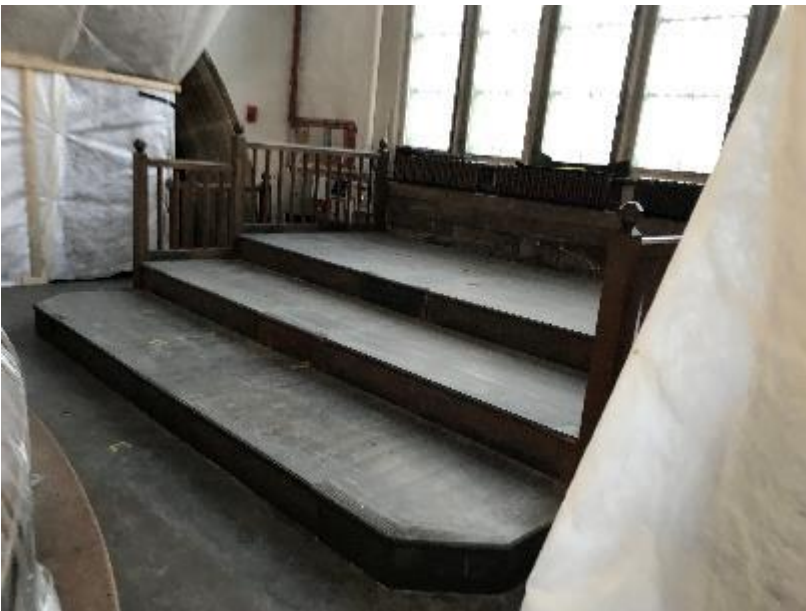
Photographs showing West End Gallery clear of pews (the memorial plaques have all been carefully removed and are in safe storage.)

Assessed as satisfactory.

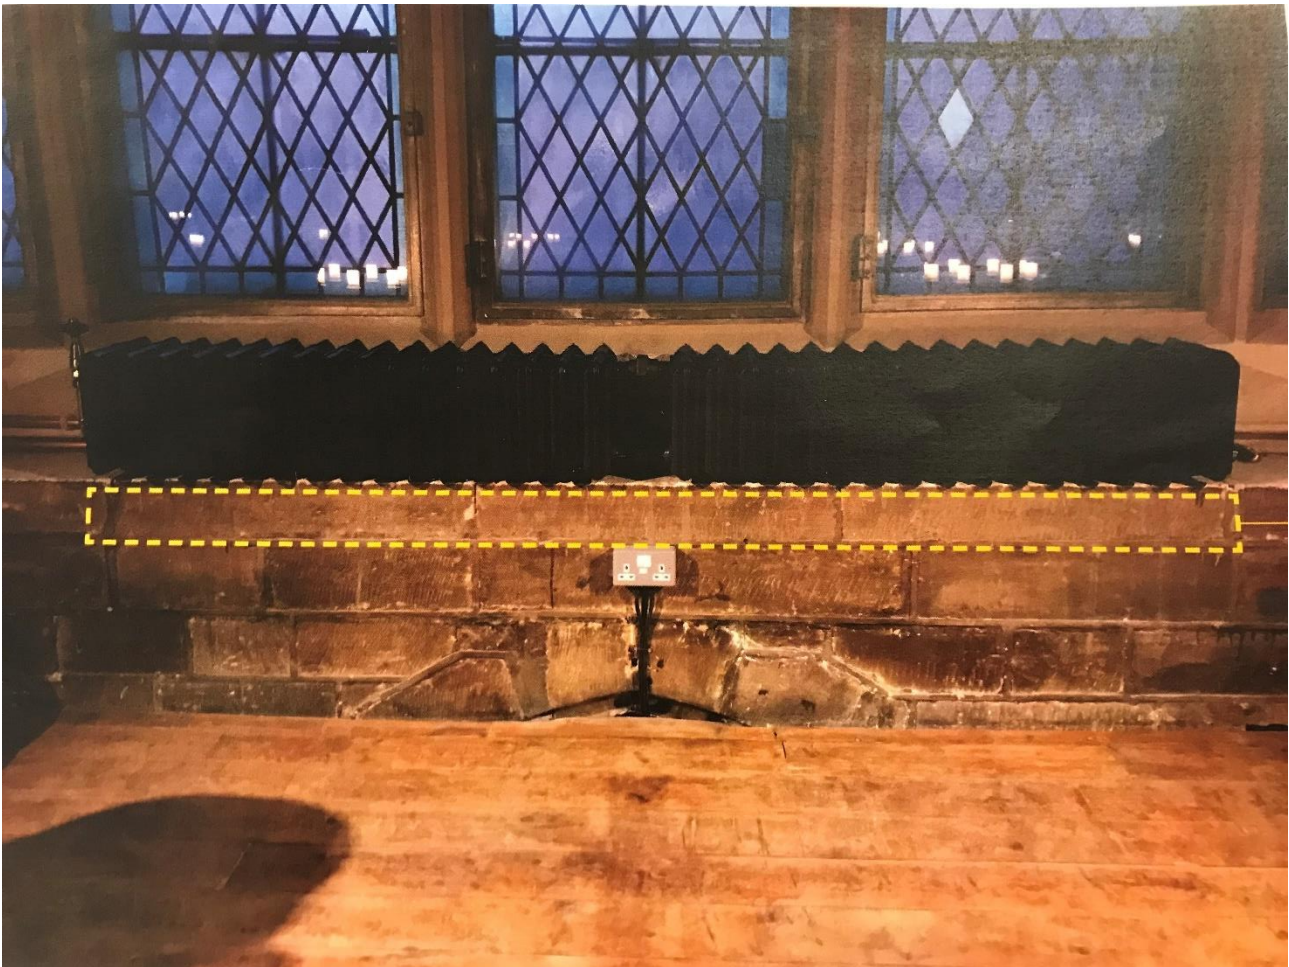
Annotated photograph showing proposed plinth location underneath the west window.

11 no. memorial plaques previously attached to the pews to be fixed to a new oak plinth underneath the west window.

Plinth to comprise 18mm quarter-sawn solid oak 250cm long by 12cm high with chamfer to the edge, finished with Osmo Hard Wax Oil.

Plinth to be fixed with concealed stainless steel or non-ferrous fixings into the perpend of the cill stones.

Plaques to be fixed to the plinth with brass screws. Where not already pre-drilled (some plaques were previously glued to the pews) plaques to be carefully drilled to allow screw fixing. Plaques to be evenly spaced.
